**Landing Gear Shock Strut Heat Damage**

**RATIONALE**

The purpose of this report is to outline the type of damage referred to as "Ladder Cracking". Discuss how it is being repaired and describe the use of a bearing material that has resolved this problem without introducing other problems.

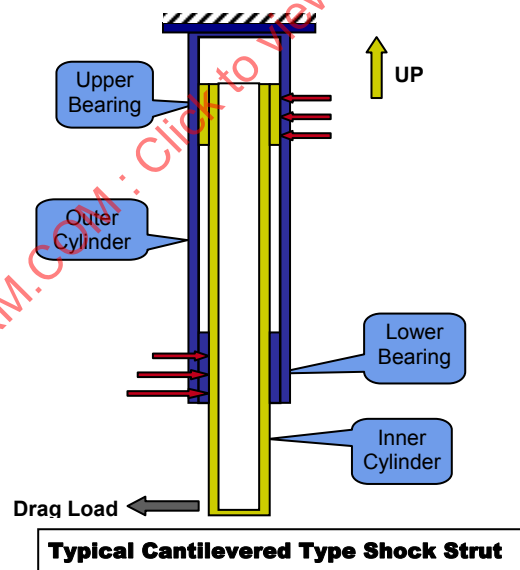
FIGURE 2 – SHOCK STRUT SKETCH

The type of strut illustrated in Figure 2, comprises of a piston/inner cylinder supported by and able to slide inside the outer cylinder. Drag and side loads exert a considerable force on each of the sliding bearings which are usually have a designed projected area bearing pressure of around 6000 psi. However, due to deflections the bearing loads are concentrated at the open end of the lower bearing and they can be considerably higher than 6000 psi.

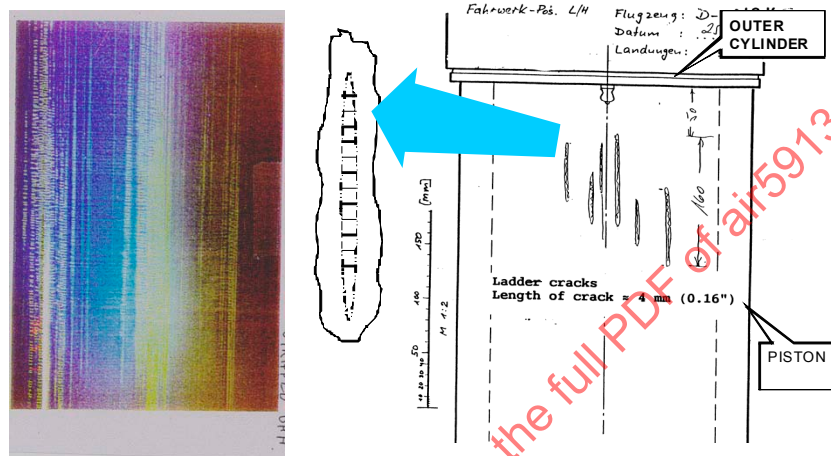
FIGURE 3 – LADDER CRACKS

The type of heat damage that is encountered in landing gear shock struts reveals itself as streaks or travel marks on chrome plated pistons. It is usually not detectable by the naked eye until it is evidenced by plating breakdown in the form of "Ladder Cracks" (see Figure 3). These cracks sometimes penetrate into the substrate material and have led to a structural failure or rejection of the part.

This damage is caused by rapid motion accompanied by high bearing pressure in a localized area. This type of action generates a localized high temperature sufficient to produce over-tempered and un-tempered martensite in the low alloy steel that most shock strut inner and outer cylinders are made from. The cracking occurs in the un-tempered areas. The cracks do not usually propagate out of this area as in most cases the damage is in the compressive area of the inner cylinder. A forward raked gear is a concern as the cracks may propagate in tension areas of the cylinder.

The heat damage is usually discovered during overhaul. The general method of detection is Magnetic Particle Inspection and/or Dye Penetrant inspection of the plated piston. Detection through the chrome is often difficult and the damage is not detected until the chrome plate has been stripped and the part has been Nital Etched. Heat damage has also been found on the inside of steel outer cylinders in the area where the upper bearing slides.

Repair is usually accomplished by a general reduction of the piston outside diameter followed by local grinding in the areas of most damage. If, after this operation, the part is still capable of being returned to service, it receives plating. The depressed areas are filled with nickel plate up to the diameter of the surrounding area. The piston is then chrome plated and ground to the original finished diameter. It has been observed also that parts that are repaired with sulphamate nickel plating and re-chrome plated do not usually exhibit ladder cracking after return to service. The common belief is that the nickel acts as a heat sink, between the chrome and the metal substrate.

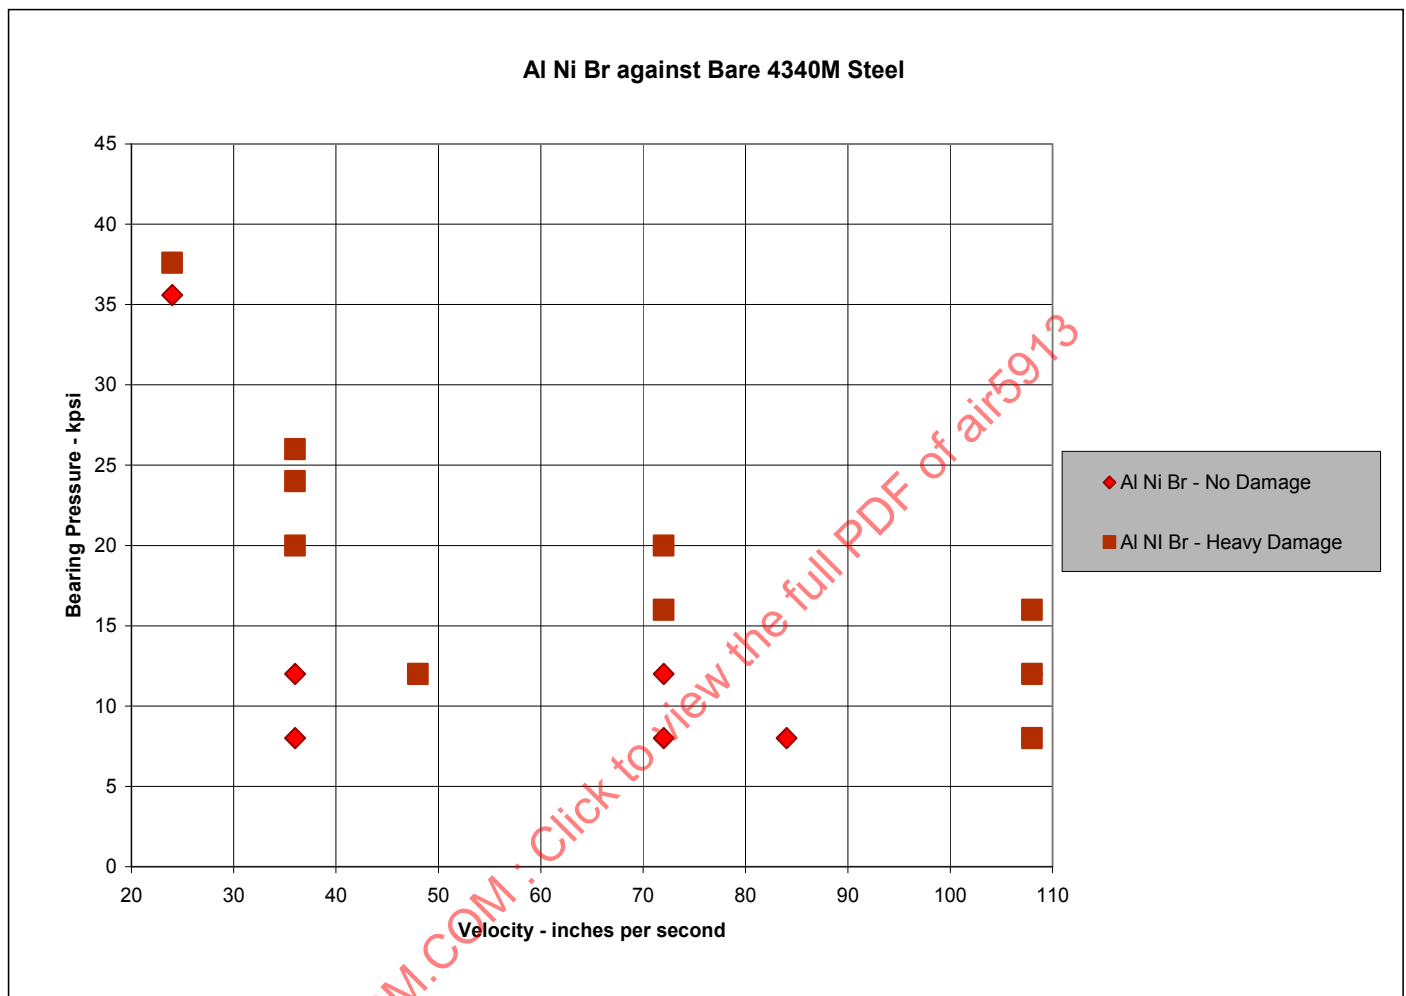
FIGURE 5 – BASELINE TEST

The heat damage was reproduced using this test method. Ladder Cracking was not produced in this test. Having established the heat damage threshold (see Figure 5), various other bearing materials were tested at the same settings. The results are shown in Figure 6. Figure 7 shows data obtained from some other materials that were tested. Copper Beryllium did not perform well. Dyflon<sup>3</sup> and Kentlon<sup>4</sup> were non metallic coatings which showed little durability.

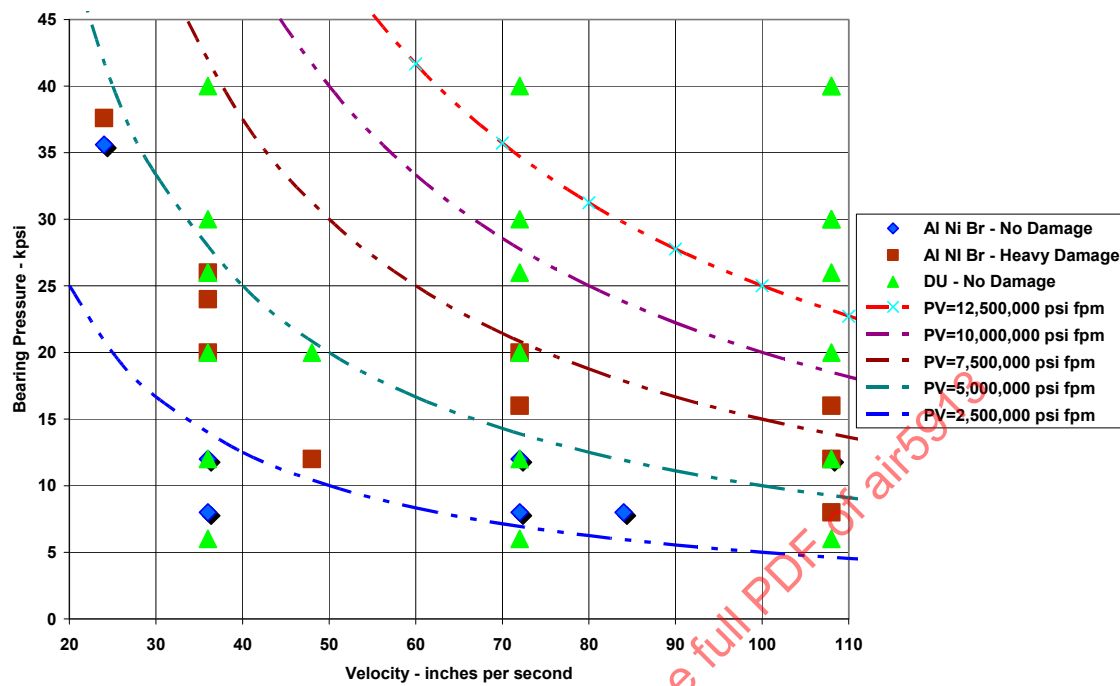
FIGURE 6 – HEAT DAMAGE COMBINED RESULTS

Tested in MIL-PRF-5606 + 2.4% Lubrizol 1395
