**Landing Gear Shock Strut Heat Damage**

**RATIONALE**

The purpose of this report is to outline the type of damage referred to as "Ladder Cracking". Discuss how it is being repaired and describe the use of a bearing material that has resolved this problem without introducing other problems.

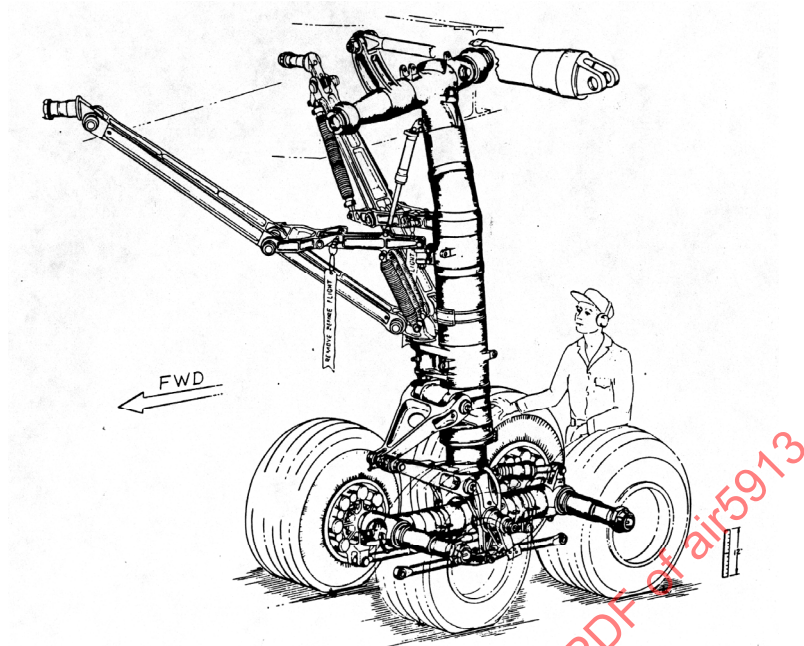
FIGURE 1 – 767 MAIN GEAR

A typical landing gear that encounters this type of damage is shown in Figure 1 these are of the cantilever design.

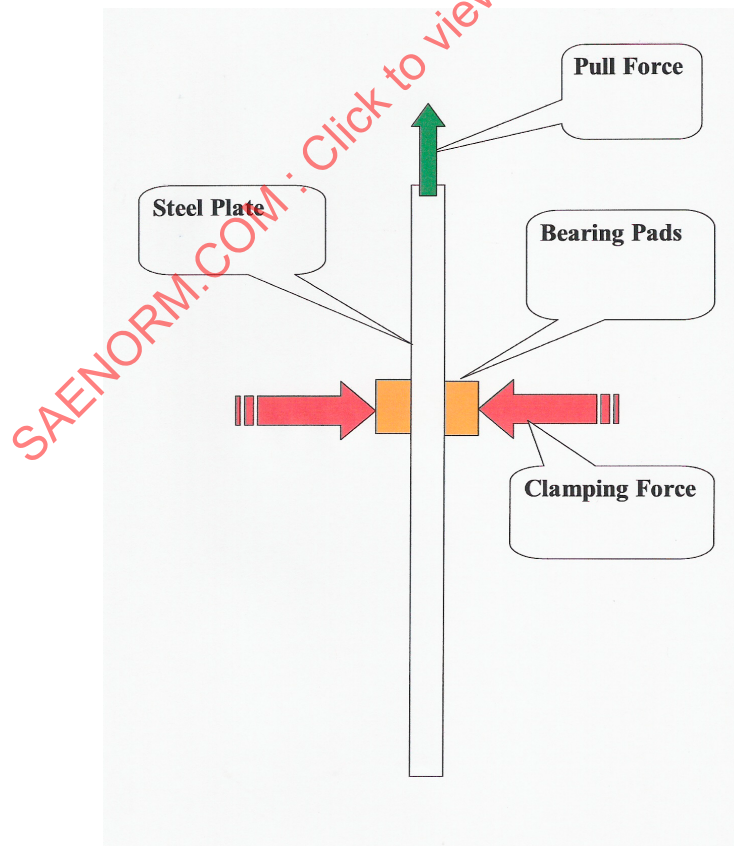
FIGURE 4 – TEST SETUP

A series of tests were run using low alloy steel plates, with 16 micro-inches finished bare steel, chrome plated or Tungsten Carbide coating on each side. A clamping fixture was used to apply a force to both sides of the plate through bearing pads of a known area. The plate was then pulled through the clamped pads at 3-10 fps velocities with pad pressures up to 60 kpsi. This was done with the pads immersed in MIL-PRF-5606 with additives and dry. Figure 4 illustrates the test set-up.
